INDOOR AIR QUALITY ASSESSMENT

**Massachusetts Department of Mental Health
Site Office Region II
40 Institute Road
Grafton, Massachusetts**

Prepared by:
Massachusetts Department of Public Health
Bureau of Environmental Health Assessment
January, 2001

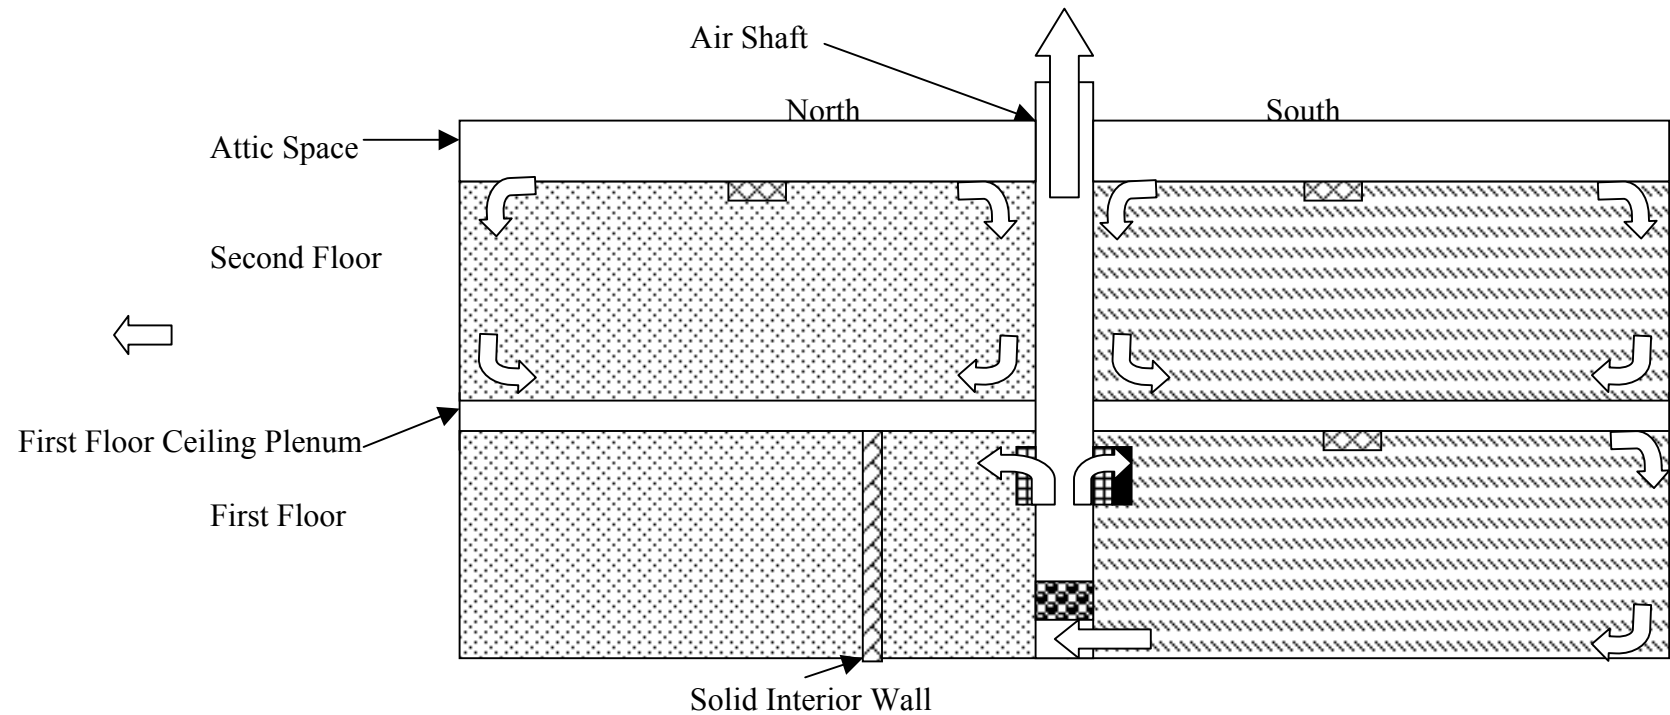
Figure 2

According to building occupants, temperature control between the first and second floor is difficult. If temperature is comfortable for first floor occupants, second floor occupants report cold temperatures. If heat is raised to make the second floor occupants comfortable, the first floor occupants report hot temperatures. The configuration of the mechanical and natural ventilation systems can contribute to this lack of temperature control. The usual design for ventilation systems evaluated by BEHA staff is to provide ventilation on a horizontal plane, with each AHU distributing conditioned air to a single floor. (see Figure 1). Instead, each AHU in this building services a vertical cross-section of the building (see Figure 2), with the original natural ventilation system continuing to operate. With this design, the increase of temperature to provide heat to the second floor would result in the natural ventilation system increasing temperature into the air mixing room heating elements. With increased heat from the heating elements, warm reheated air is introduced into the first floor. Without the AHUs operating to provide fresh air to the building to temper air, increased complaints of excessive heat would be expected on the first floor.

Configuration of Heating Zones in MDMH Office

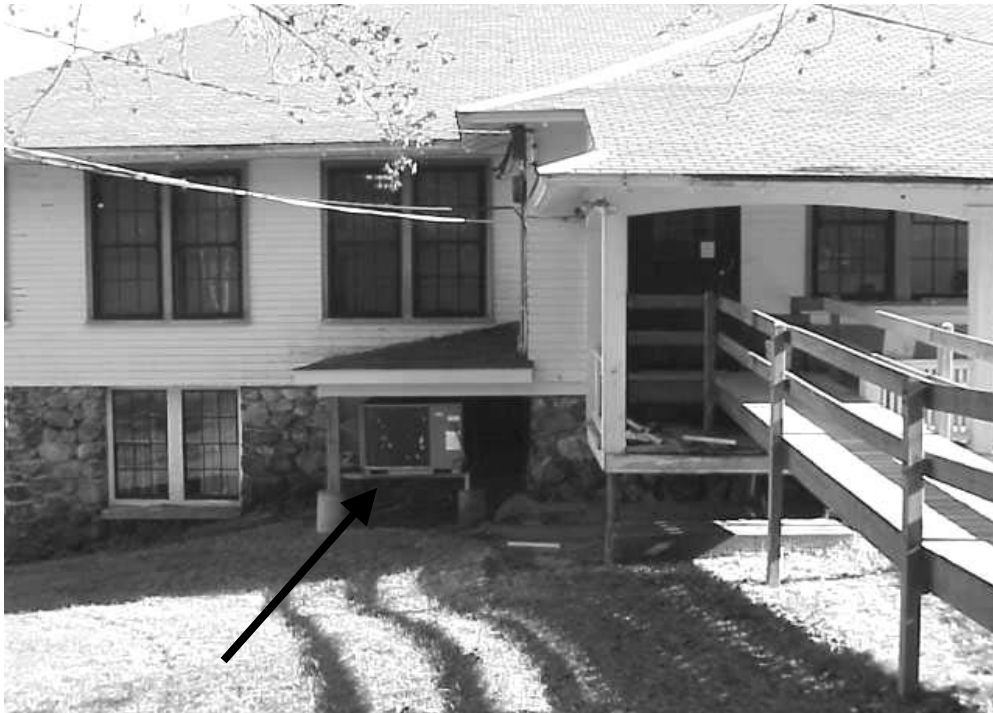
Picture 1

The condition of the AHUs servicing the building may also limit operation. Each AHU was installed at the base of the front of the building, beneath the edge of the sloped roof. Building occupants report that the AHUs and ductwork were repeatedly damaged by accumulated snow sliding from the peaked roof. Several conditions confirm this report. The top cover bolts to the south AHU are a different color than the rest of the casing suggesting that they have been replaced. Sealed within the casing against the coils is a free standing filter. All routine methods for installing filters through outside access panels are of insufficient width to install a filter of the size currently installed. It appears that this filter was inserted in the casing when the new top casing cover was installed. The age of the filter could not be determined. Finally, in an effort to prevent further damage, a small roof structure was constructed over the ductwork and AHUs (see Picture 10). Whether these repairs restored each AHU to an adequate operational capacity could not be determined.

AHU Servicing North Zone of Building

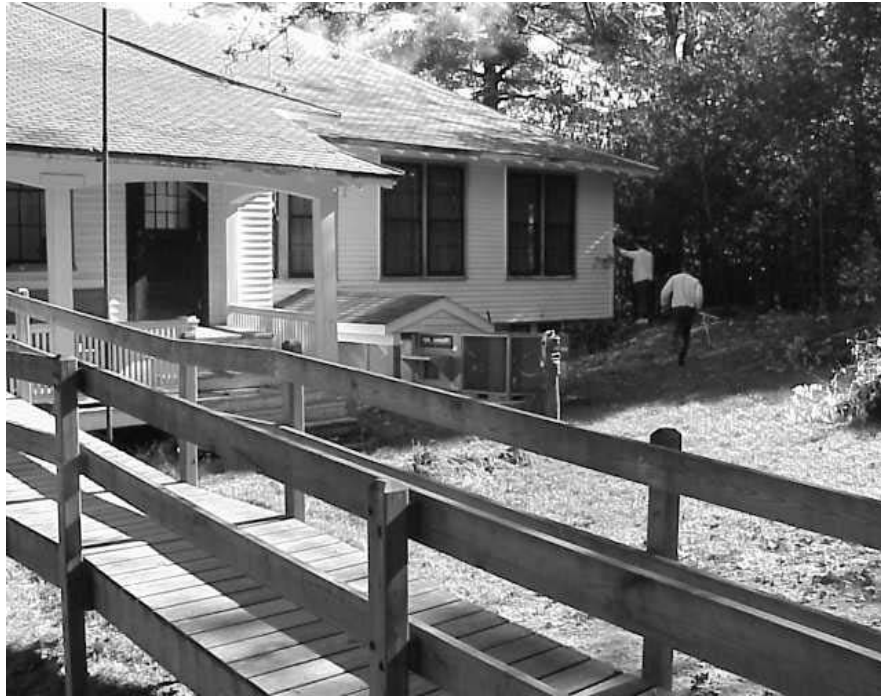
Picture 2

AHU Servicing South Zone Of Building

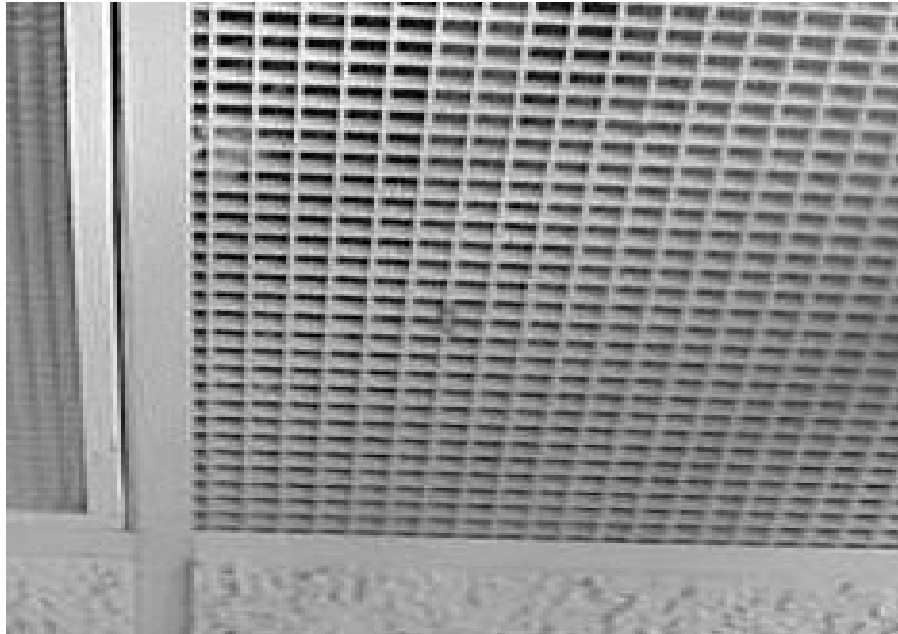
Picture 3

the suspended ceiling on the second floor (see Picture 3) indicates that the renovations were an energy conservation measure. A steam plant located in a separate building supplies heat for the building (see Picture 4).

Passive Vent Open To Suspended Ceiling and Fiberglass Insulation

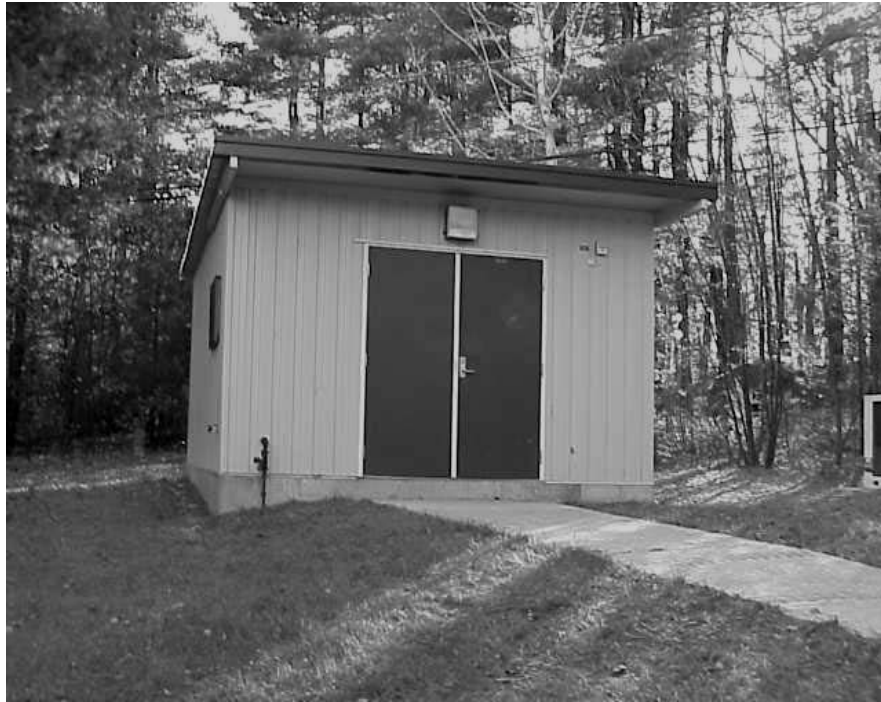
Picture 4

Site Office Building Steam Plant

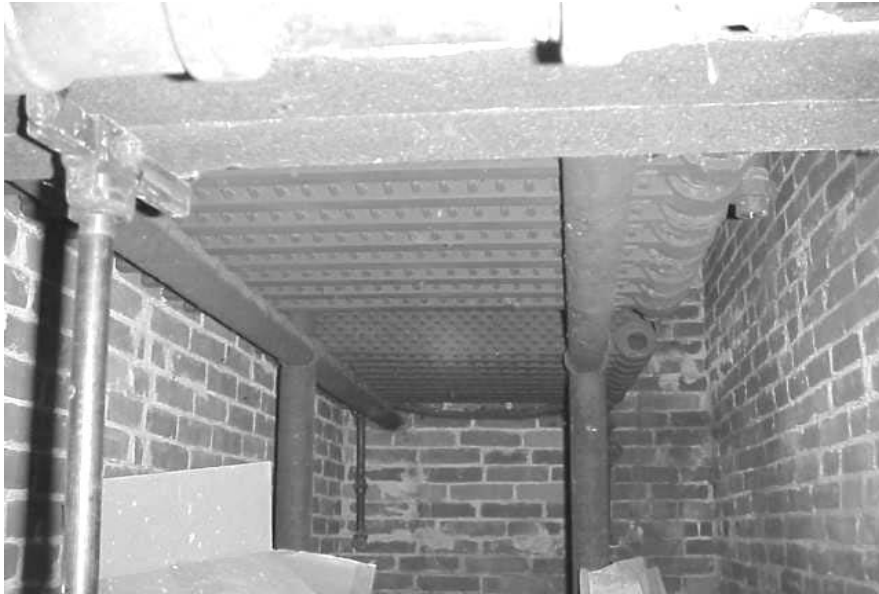
Picture 5

Heating Elements in Air Mixing Room

2. As part of the renovation, ensure that the heating elements in the air mixing room are deactivated for better temperature control.
3. Examine the feasibility of installing general mechanical exhaust ventilation.
4. Consideration should be given to reconfiguring the ventilation system ductwork so that each AHU services one horizontal floor in order to better control heating.
5. To decrease condensation in ductwork during summer months, consider insulating the exterior of ducts.
6. Examine the feasibility of extending restroom exhaust vent out the wall of the building.

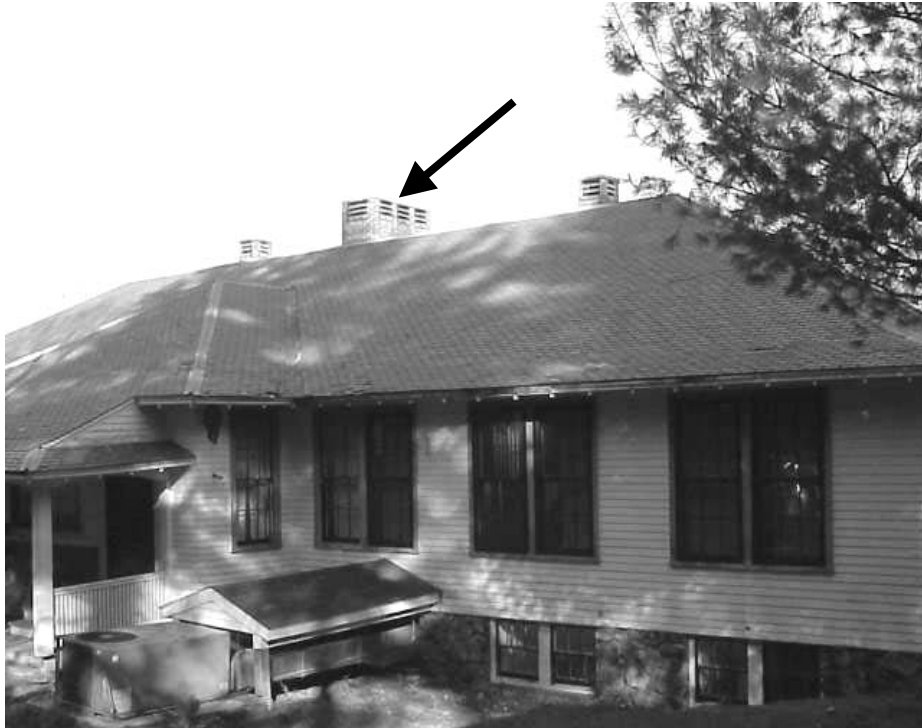
Picture 6

Terminus of Brick Airshaft on the Center of the Roof

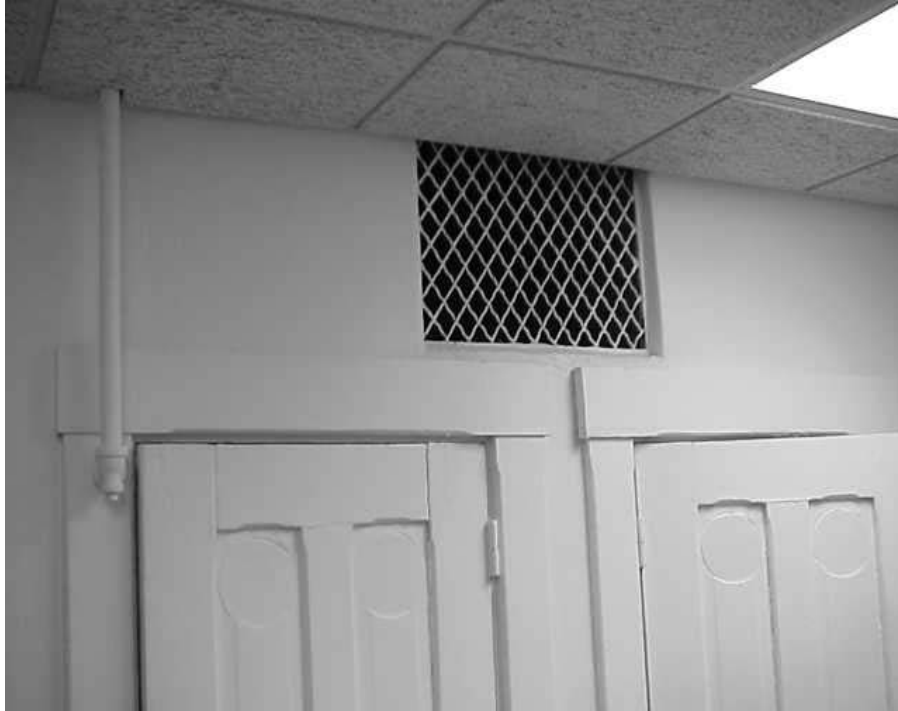
Picture 7

Vent In Wall Of The Air Mixing Room Near Area 99 (AIT Room)

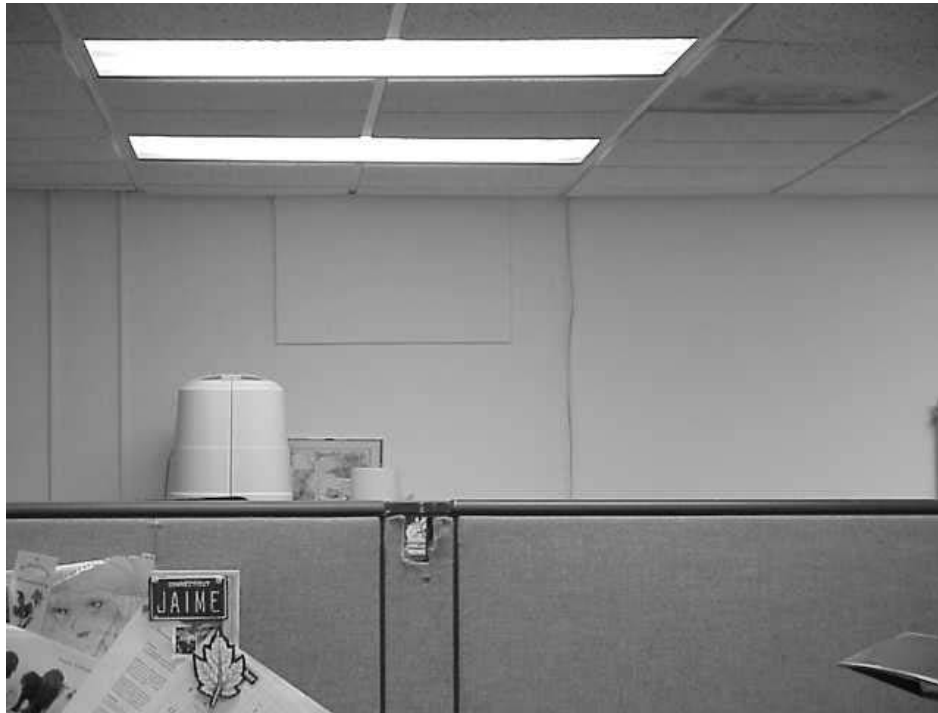
Picture 8

Sealed Vent in Wall near Area 37

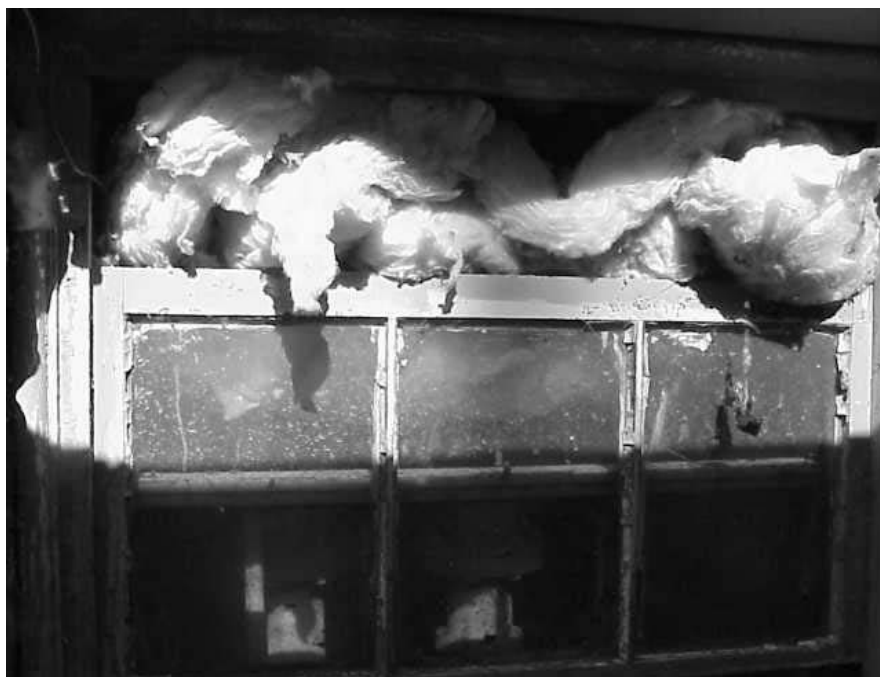
Picture 9

which draws cold air from the basement area into the heating elements. A louvered or sash window located near the airshaft typically controlled fresh air in this type of system. Sash windows exist in the utility room and were sealed shut and insulated (see Picture 9). As previously mentioned, this ventilation system appears to have been abandoned. While airshaft openings were sealed, heating elements in the air mixing room were emitting heat, indicating that the system was not completely abandoned and is still receiving steam from the supply plant. These conditions would create negative pressure in this area drawing air through seams of the utility room door, resulting in the continuous re-heating of air without the introduction of fresh outdoor air.

Sash Window in the Utility Room Sealed with Insulation

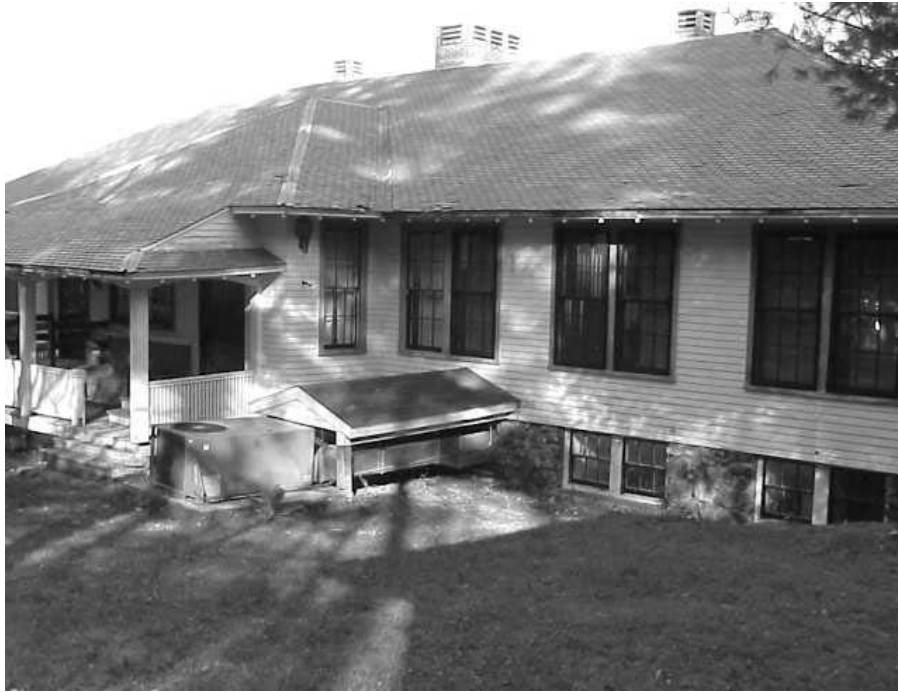
Picture 10

Small Roof Structure Constructed Over Ductwork and AHU

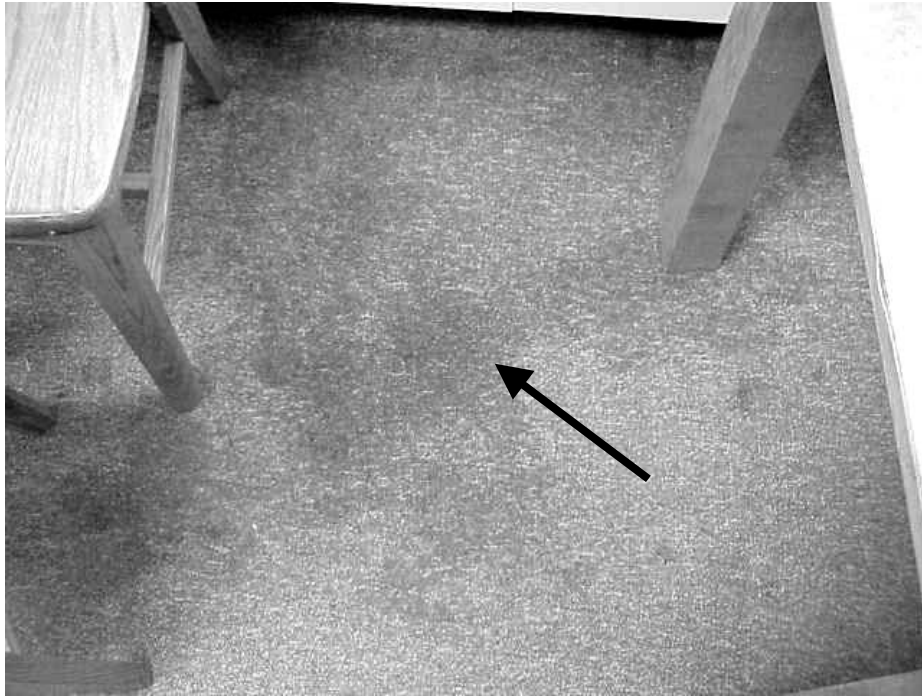
Picture 11

Building personnel reported that leaking condensation from the heating system in the conference room has led to chronic moisture problems in the wall-to-wall carpeting. Moisture sampling for carpeting in this area was conducted. Most areas of carpeting had non-detectable levels of moisture, however moisture measurements near the exterior wall under the heating system had moisture content measurements of 39.9 to 100 percent (saturated moisture content) (see Picture 11). Carpeting along the exterior wall in work area 7 had water stains.

Carpeting can be susceptible to mold growth if allowed to remain moist. If mold has colonized carpeting, the addition of moisture can result in increased mold growth. The American Conference of Governmental Industrial Hygienists (ACGIH) recommends that carpeting be dried with fans and heating within 24 hours of becoming wet (ACGIH, 1989). If carpets are not dried within this time frame, mold growth may occur. Water-damaged carpeting cannot be adequately cleaned to remove mold growth. The application of a mildewcide to moldy carpeting is not recommended.

Water Saturated Carpet in Meeting Room

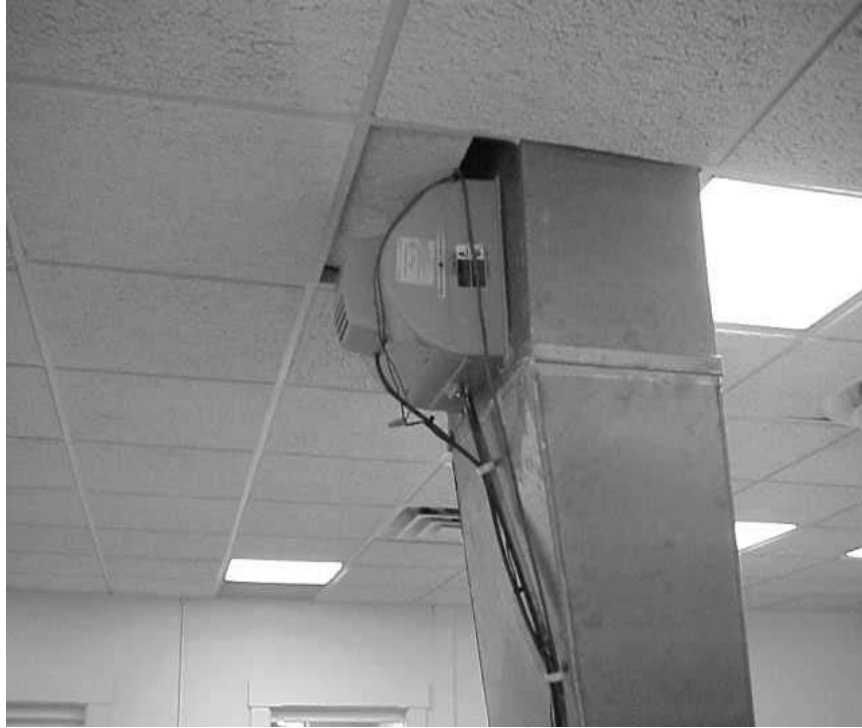
Picture 12

Each duct on the second floor has a condensation pump to remove collected moisture from the ductwork (see Picture 12). The condensation pumps are connected to the drainage system by clear plastic flexible hoses (see Picture 13). The interior of these flexible hoses is coated with microbial growth (see Picture 14). As the ventilation system operates, negative pressure is created which can draw air from the drain system through these hoses and into the unit. This can be a means for microbial growth and associated odors to be drawn into each unit and distributed by the HVAC system.

Condensation Pump To Remove Collected Moisture From The Ductwork

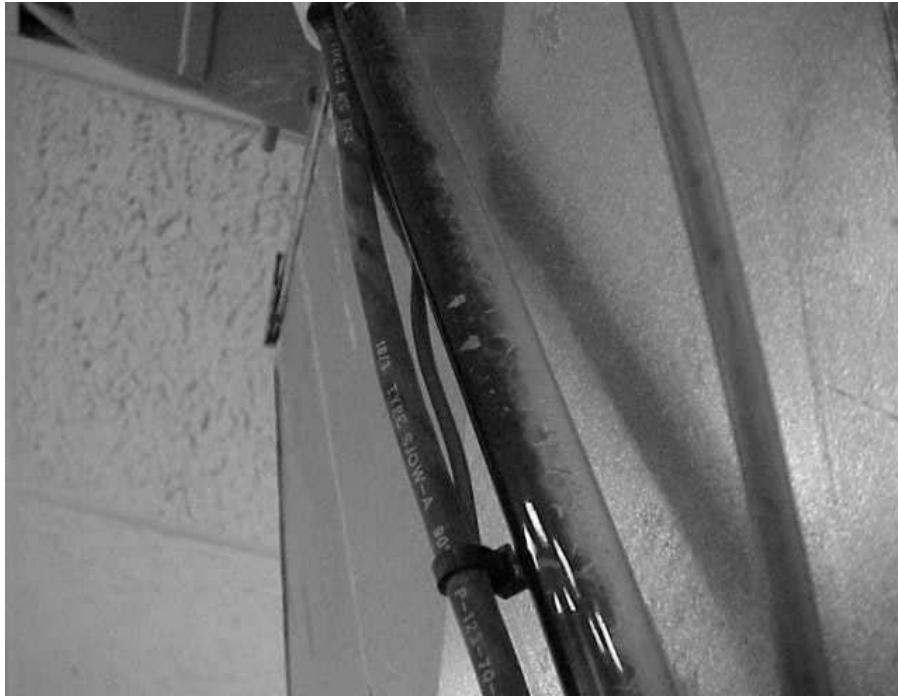
Picture 13

Clear Plastic Flexible Hoses Connected to Condensation Pump

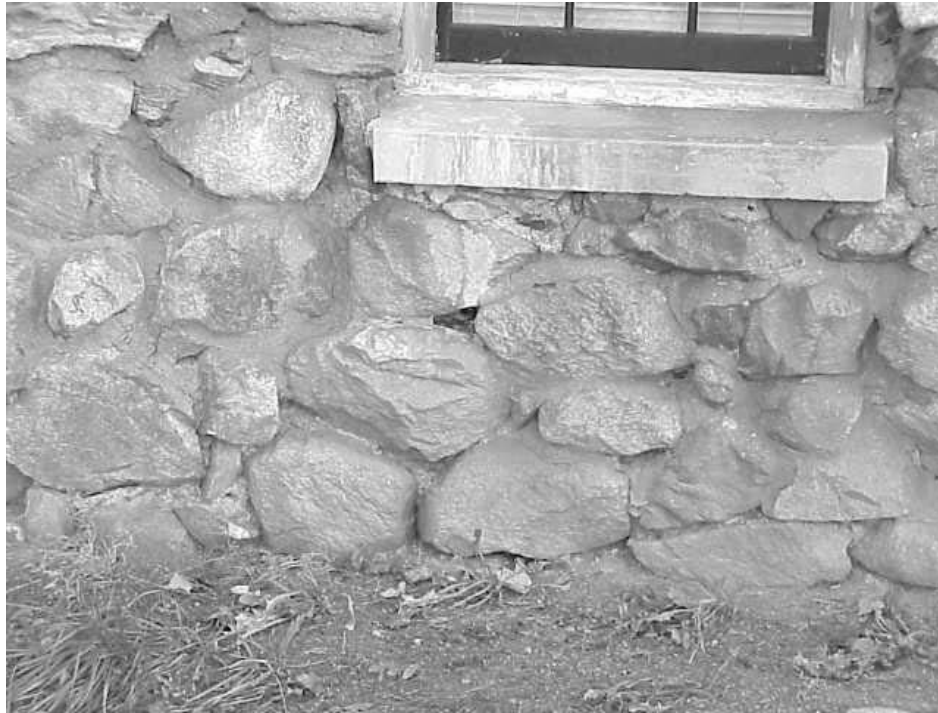
Picture 14

Building occupants report that the site office is infested with mice, chipmunks and squirrels. A number of means of ingress through the exterior walls and windows were noted around the building (see Pictures 15 and 16). Occupants reported that pesticide applicators routinely remove mouse carcasses from traps within the building. Rodent infestation can result in indoor air quality related symptoms due to materials in their wastes. Mouse urine contains a protein that is a known sensitizer (US EPA, 1992). A sensitizer is a material that can produce symptoms in sensitive individuals (e.g. running nose or skin rashes). A three-step approach is necessary to eliminate rodent infestation:

Means Of Ingress through the Exterior Wall

- f) Regularly clean crumbs and other food residues from toasters, toaster ovens, microwave ovens, coffee pots and other food preparation equipment.
 - g) Holes as small as ¼” provide enough space for rodents to enter an area. Examine each room and the exterior walls of the building for means of rodent egress and seal. If doors do not seal at the bottom, install a weather strip as a barrier to rodents

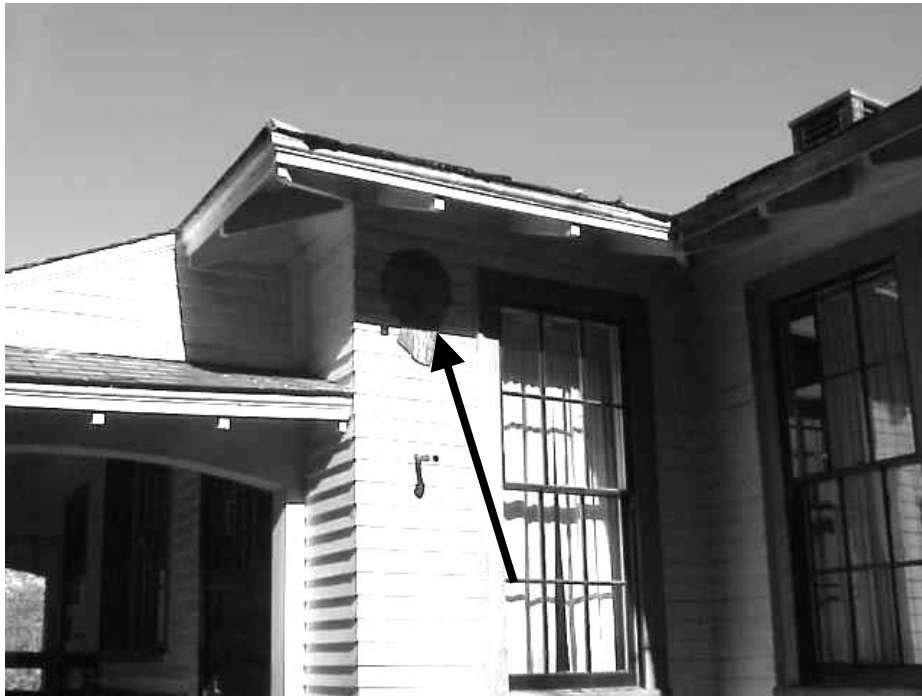
Picture 15

Means Of Ingress through the Exterior Wall
